# Microbiologically Influenced Corrosion (MIC)

## from a Surveyor's Point of View

Discussion Paper

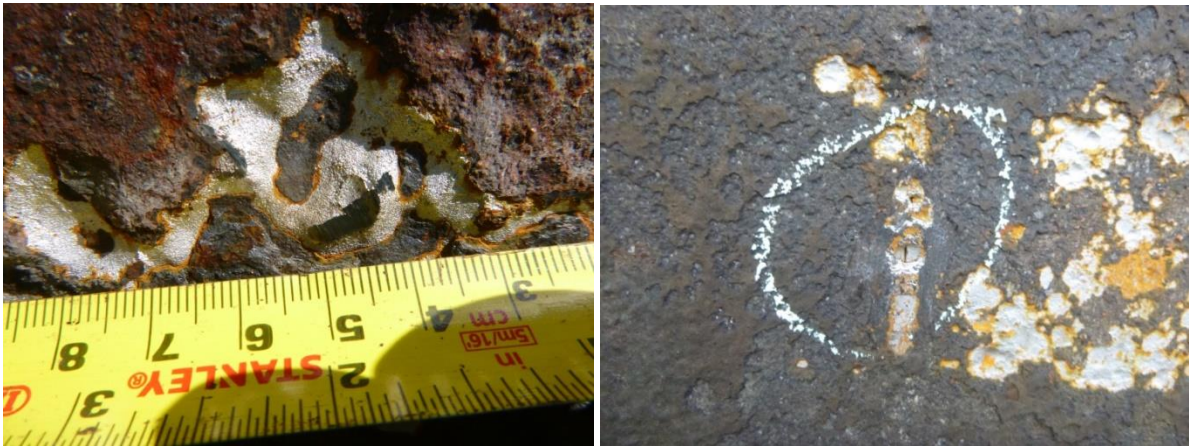
This corrosion is characterised by pits with a shiny metallic appearance, often surrounded by brown deposits and is found below or at the waterline.

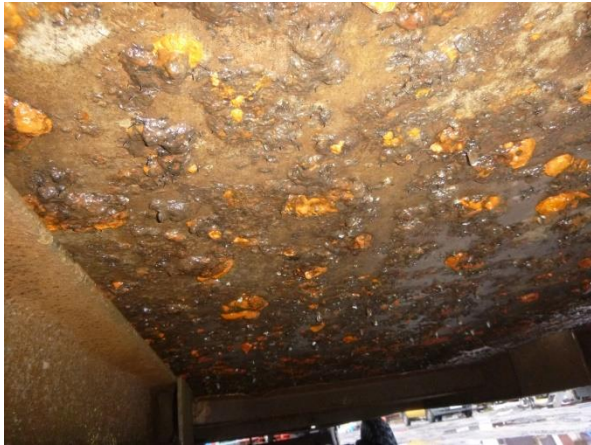
But this becomes visible only after the hull is washed, while before the wash, the appearance is very different and does not suggest the existence of corrosion damage under the layers of biological fouling and corrosion products buildup, as shown on the picture below.

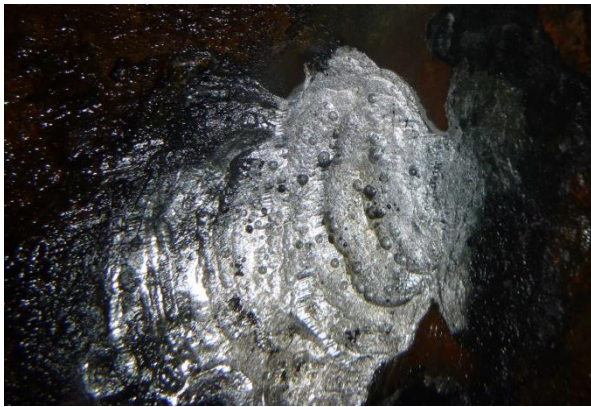
Here is a link to a video I have taken on how the corrosion damage is revealed after scraping and water wash - <https://youtu.be/PpyCgR5yaYM> .....and a close-up picture of the pit which was hidden under the deposits.

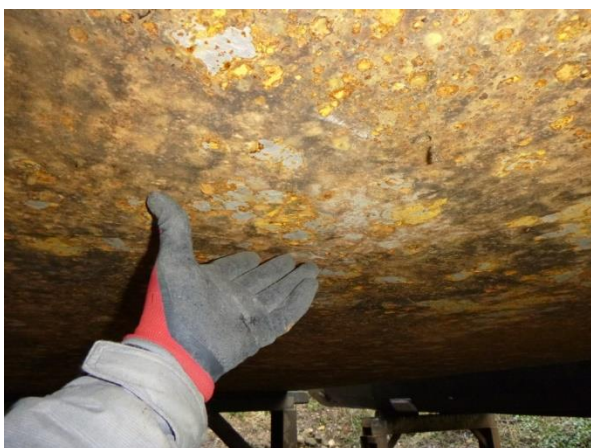
Very often, after the hull is washed, this pitting is found to be relatively shallow (about 1mm depth), but very large diameter individual pits, often merging into large pools.

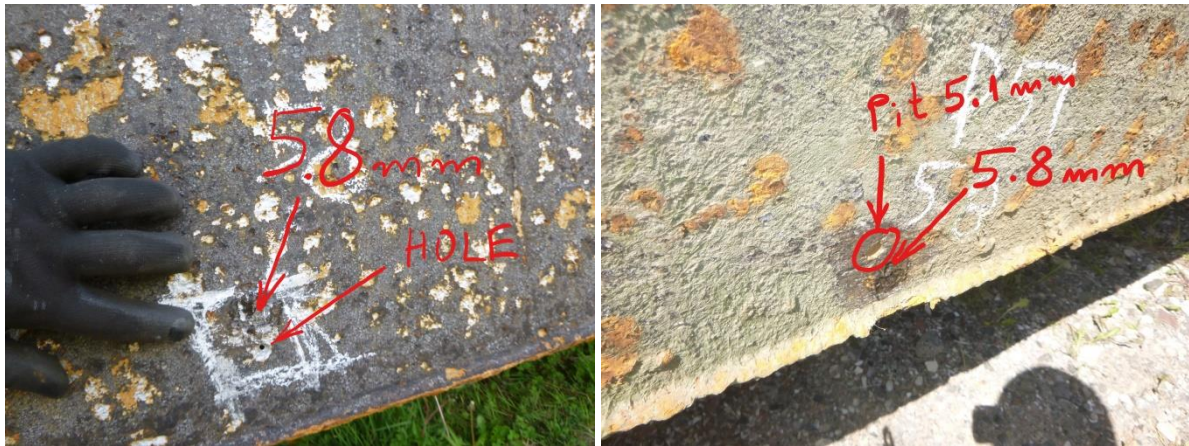
From the surveyor's point of view, it is important that sometimes the pits are extremely deep and even have gone through the plate. I will come back to this finding later, but the pictures below illustrate a boat which was due blacking and the boatyard stopped washing it, as holes in the hull were being discovered. This boat is a very good example, on the first picture - a washed section of the hull is shown, while on the second picture, an adjacent (not washed) section is shown with plate

thickness and pit depth marked in red. It is easy to see how a surveyor could miss (and in this case has actually missed) severe pitting and holing of a hull which is giving normal ultrasound thickness measurements.

- 7.1. With MIC present on the hull, visual observation and hammer sounding opportunities and reliability is greatly reduced. A relevant example is given in point 2 above, where the surveyor was misled by the relatively good thickness measurements and did not have a good opportunity to visually examine the unwashed hull. Hammer sounding a base plate with a 10mm thick layer of marine growth and corrosion products from MIC is not very reliable.

- 7.3. If the findings from the sample patches are of concern, i.e. deep silvery pits (but remember it will not be silvery until you wash it), crevices in weld seams, tapered/corroded sacrificial edge.....then I would like to see the boat pressure washed or my report will be full of disclaimers.

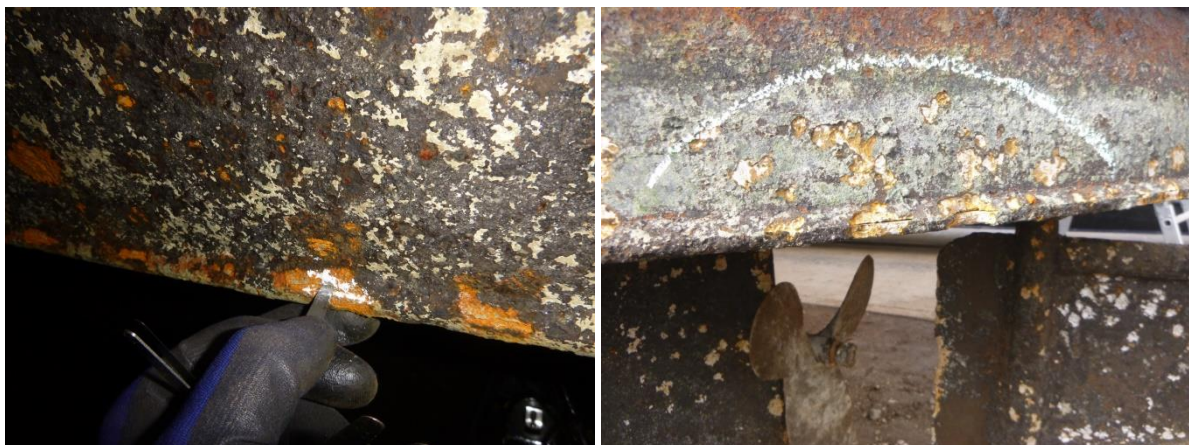
This corrosion is also often found to affect the welds and creep under as demonstrated on the pictures below. In some cases, when the fillet weld between the base and side plates was ground, it was found that the corrosion has gone completely through the weld face and only the internal fillet weld was ensuring watertightness.

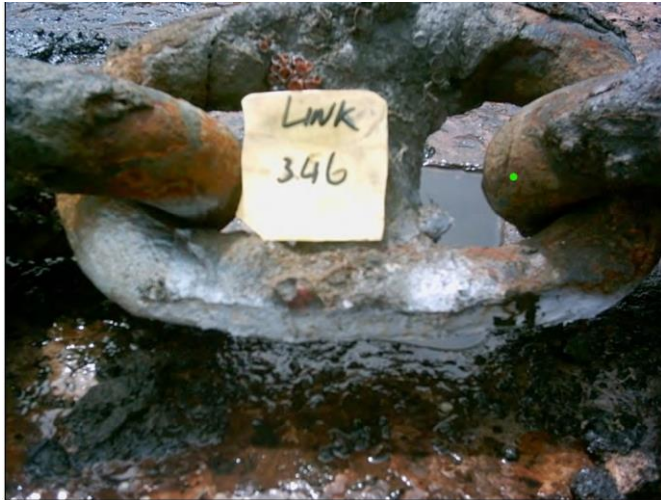
Similar symptoms have been observed by the Health and Safety Executive sponsored study on mooring systems in Scotland and the picture below is from a chain link which has no electrical contact with dissimilar metals and no external power sources had been applied there.

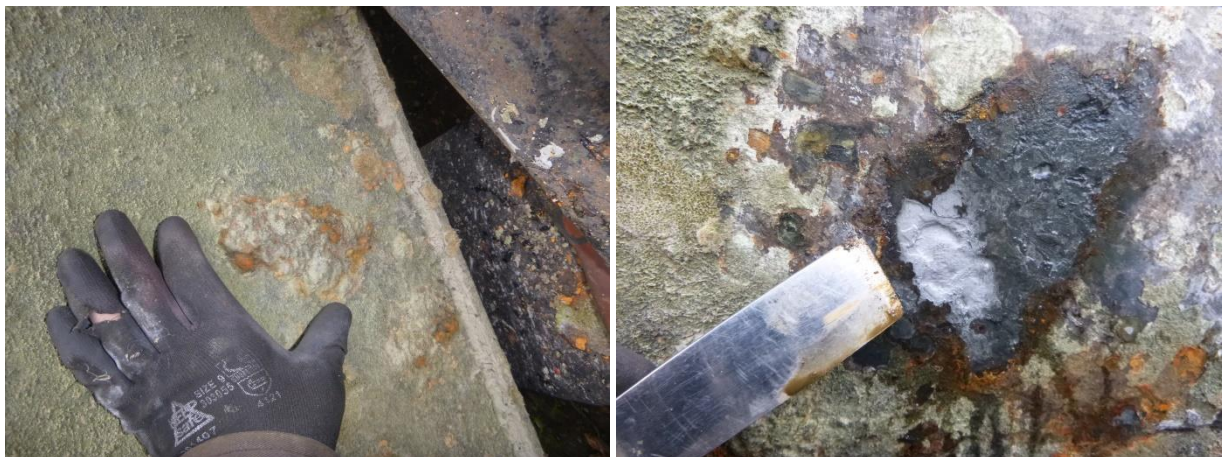
I have also observed the same symptoms on piling which is not electrically connected to other metals and also on a boat which had been with no batteries on board, no electric systems or power at all and not galvanically connected to any other structure for more than 2 years. The silvery deposits appeared after the wash (pictures 1 and 2 below). The fact that the silvery surface is discovered under a film/crust is also evidence that there was no currently active galvanic corrosion or corrosion caused by external source, as if that was the case, the corroding metal would have been exposed.

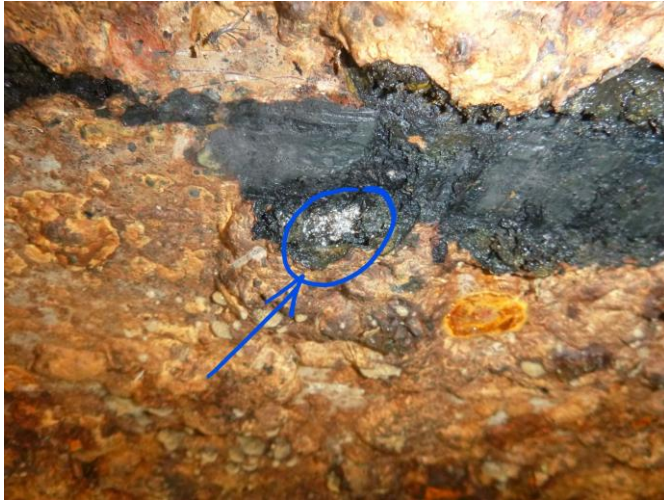
This silvery material is sometimes found suspended in the thick layer of corrosion products and not attached to the hull, as shown on the picture below and in this video - <https://youtu.be/ebxXemW6yrQ>. It comes to show that this is not the hull metal, but rather a product of a corrosion process (such as Mackinawite, Pyrite or other FeS crystalline structure

associated with Sulphate Reducing Bacteria (SRB) activity.) I have also tried to polish mild steel and the surface can never be as bright as this silvery substance.

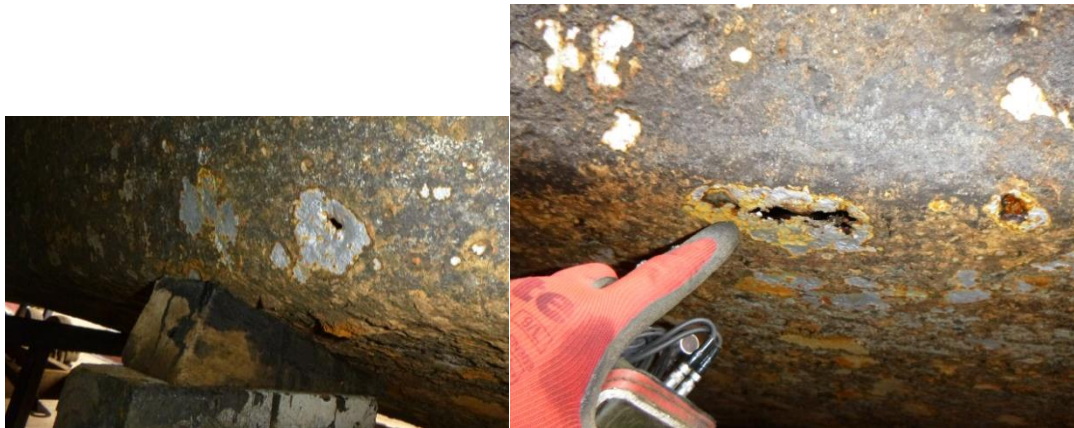
I find that “electrolysis” is often used as a blanket term when some sort of corrosion is discovered, while it relates to a method or technique rather than a condition. It is often forgotten that the corrosion, in general, is always an electro-chemical process and to explain it, one has to identify the presence of the four elements: anode (where the oxidation happens and metal is lost), cathode (where the reduction happens), conductor to connect the cathode with the anode and electrolyte to close the circle. Often it is hypothesised that electricity flow within a galvanic couple or from external power source causes the symptoms described above, but here is one of the real live examples I have come across, which disproves this hypothesis; A narrow boat was taken out of the water for blacking, it came under its own power and the owner did not report any leaks. When the boat was pressure washed, numerous holes in the bottom of the silvery pits were discovered – examples on pictures 1 and 2 below. Some of them were rather large and definitely capable of sinking a boat which did not even had a bilge pump. Apparently these pits (and holes!) were there already and not a result of an active electric current flow. What was keeping this boat still afloat was the biofilm and corrosion product buildup which was blocking the holes! If the pits were caused by an electricity flow between a galvanic couple or an external power source, the pits would have displayed bare metal surface as they were the anode side and were losing metal. We all know how the hull anodes look when they are working normally – bare metal with pitted surface.....In this case

however, everything has been happening in the isolated site under the crust/film, typical for microbiologically influenced corrosion as discussed and illustrated in section 4 below.

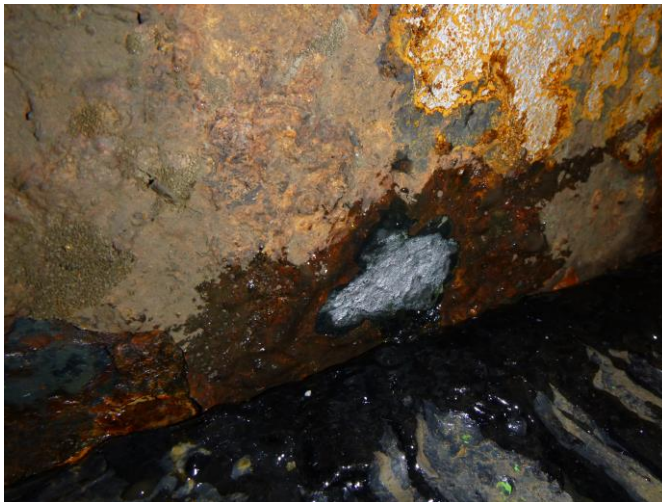
I have treated corrosion products taken from the silvery pits with hydrochloric acid and compared it with corrosion products taken from above the waterline. The following video shows bubbles (which smelled like rotten eggs) being released from corrosion products from the base plate of a narrow boat on the Grand Union Canal –

<https://youtu.be/y4xvIAuO47I>. The pit, after it was cleaned, is shown on the picture below.

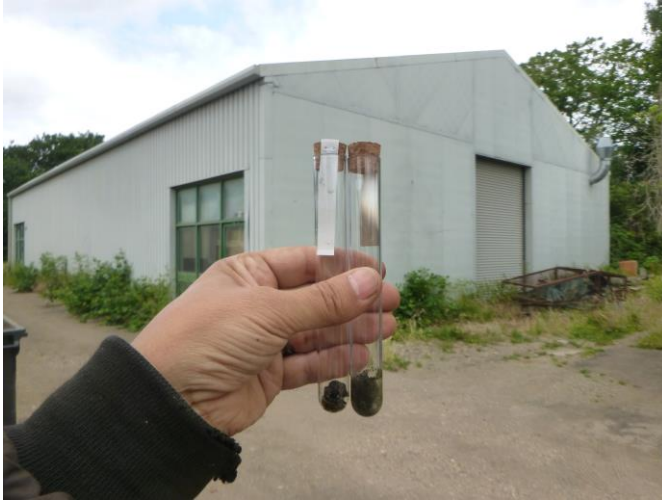
I have also compared the corrosion products from a silvery pit on the bottom of a barge on the Thames and corrosion products around its hatch coamings by adding hydrochloric acid and inserting lead acetate paper to test for hydrogen sulphide. The dark paper indicates presence of hydrogen sulphide – the right test tube on the picture below is with the corrosion product found in the bottom pit, the left is the corrosion product found around the hatch on deck.

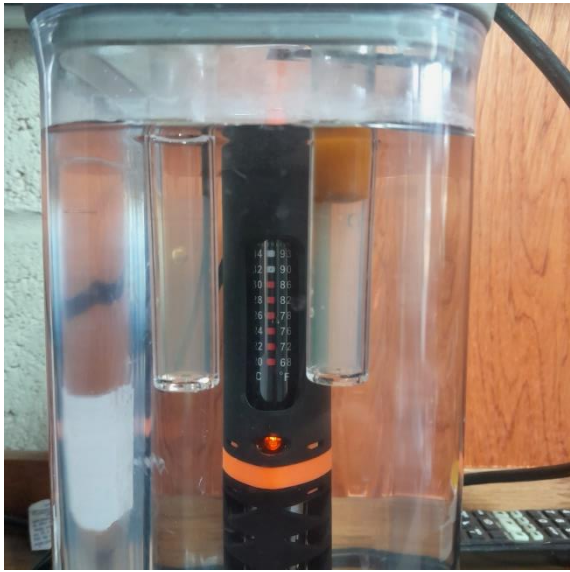
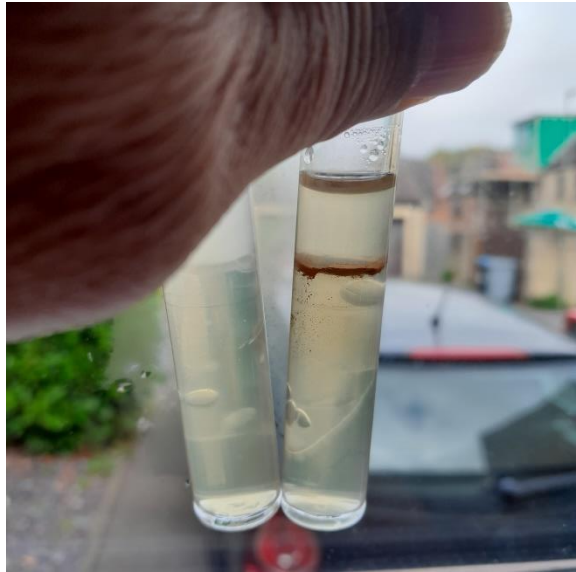
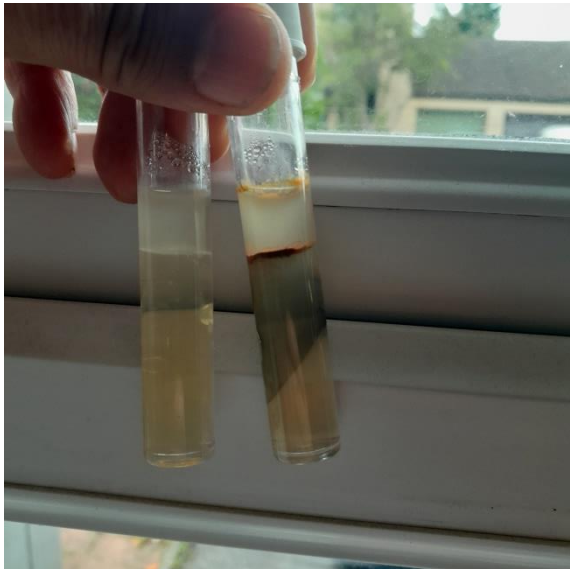
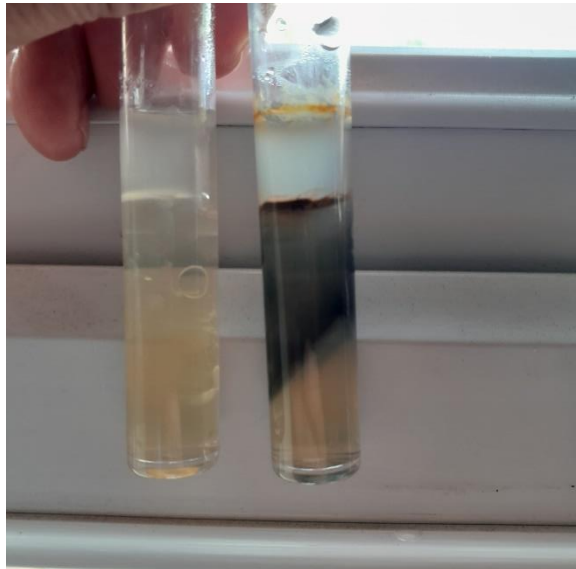
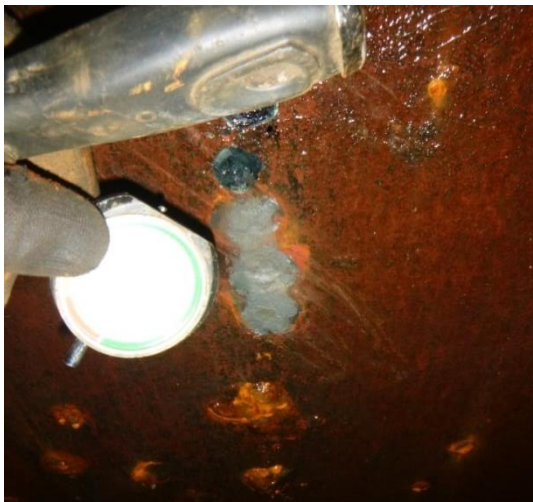
The most convincing test however, was the one where instead of using water from the canal or river (which usually also contains SRB) as a control sample, I used bottled mineral water which contains Sulphates, but no SRB. I took corrosion products from the boat's hull when it had been out of the water for a couple of hours and put them in a test bottle filled with mineral water. Then I let it stay for a couple of hours. After that, I filled one test tube with clean mineral water from the same bottle (control sample) and the other from the test bottle with the corrosion products (test sample), then incubated the two samples together. I was able to see some SRB growth (the test gel turning black) in the test sample on the first day and on the second, the growth had turned black already, while the control sample remained unchanged (indicating no SRB present). Below are pictures taken in sequence on day zero (in the incubator), day one, day two and day three. The control sample is on the left, the test sample is on the right. This experiment shows that SRB were present in the silvery pits and in the film which develops over them. It has also eliminated the chance of false positive results which can be caused by the use of canal or river water for the samples. Where I have scraped the corrosion products/film from the pits, the plate had the typical silvery deposits and other undisturbed corrosion formations can be seen in the vicinity – picture 5 below. Note that the boat had been out of the water for a couple of hours already, hence the bacteria will stay alive even in damp and oxygen-rich conditions.
